Intel[®] Pentium[®] III Processor Specification Update

Release Date: June 2001

Order Number: 244453-031

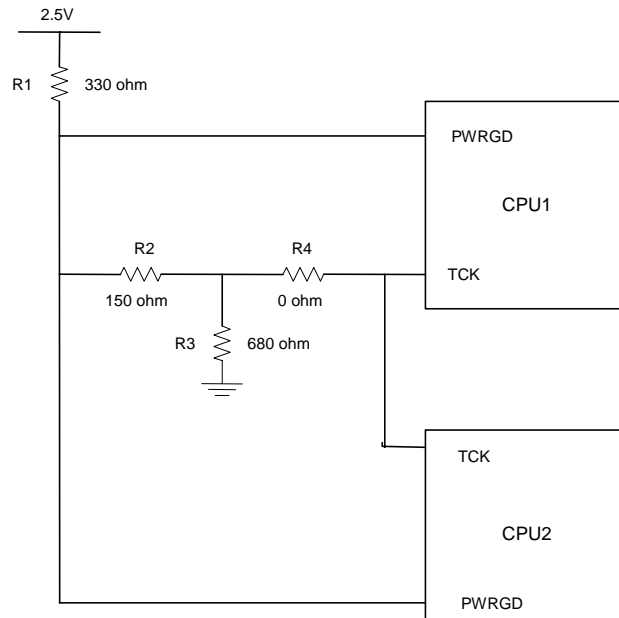
Pentium® III Processor with 512KB L2 Cache Platforms Workaround

Assumes the inputs to the CPU_PWRGD are open collector signals that are Wire-ANDed together

- The example workaround circuit assumes that the PWRGD inputs into the processors are open collector. Tying the PWRGD inputs together in a Wired-AND fashion allows each processor to receive PWRGD at the same time but at the latter of the 2 separate PWRGD assertions. If separation of the PWRGD inputs to each processor is required, extra circuitry will be required.
